HEWLETT-PACKARD COMPANY
Solid State Laboratories
1501 Page Mill Road
Palo Alto, California 94304

HIGH STRENGTH HERMETICALLY COATED OPTICAL FIBERS

FINAL TECHNICAL REPORT

Contract No. N00123-80-C-0245

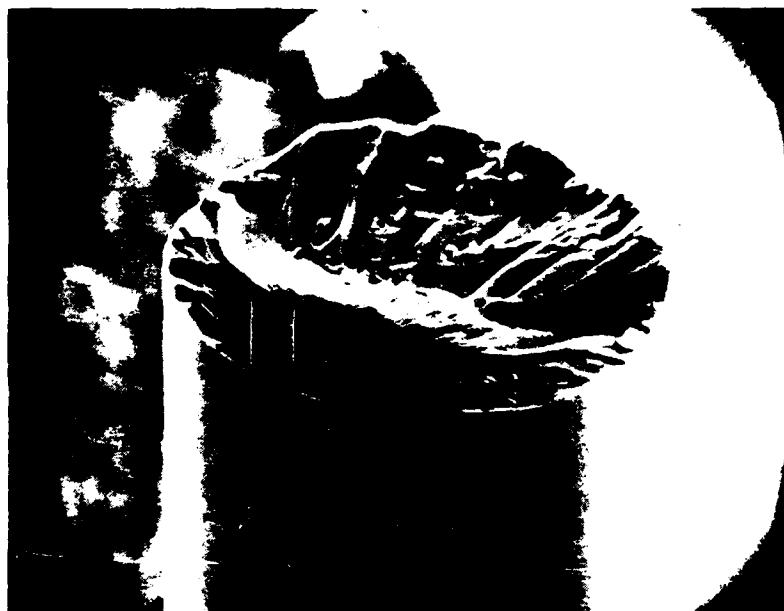
Figure 16 shows a typical fracture surface which originates from a weak (< 1.4 GPa) failure. A smooth semi-circular "mirror" region is surrounded by a "mist" region and then a very rough "hackle" region. The entire pattern appears to radiate from a point on the side of the fiber in the center of the mirror region. Studies of fracture in glass samples having surface stress raisers at known locations have shown⁽²²⁾ that the fracture is actually initiated at the point from which the pattern appears to radiate. These studies

Figure 16. SEM photo of a fracture surface
originating from a 0.35 GPa flaw.

Fractures with mirror surfaces originating at the edge of the fiber, like those in Figure 16, are by far the most common type of fracture. In some cases, additional features can be seen which give further clues to the origin of the fracture. For example, in Figure 17, we show a fracture surface with a surface-originating mirror surface. In contrast to the fractures discussed above, however, this fracture surface shows a long scratch containing an embedded particle right at the fracture origin. The particle was examined by X-ray microprobe analysis and found to contain Zr. The flaw may have been caused by the impact of this particle on the hot zone of the fiber inside the ZrO_2 susceptor in the fiber drawing tower. The depression produced by the particle would lengthen into a "scratch" as the fiber lengthened by $\gg 10,000$ in pulling.

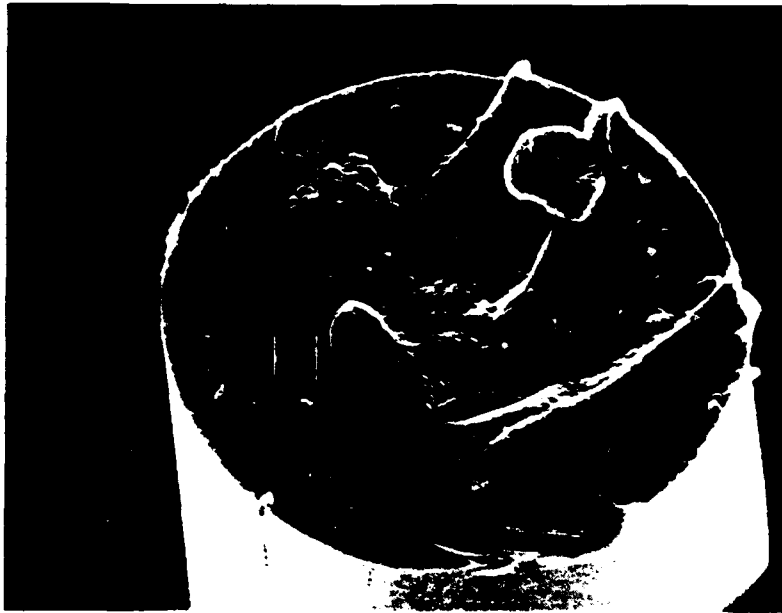
Figure 17 SEM photo of scratch at origin
of .35 GPa proof test break (500 X).

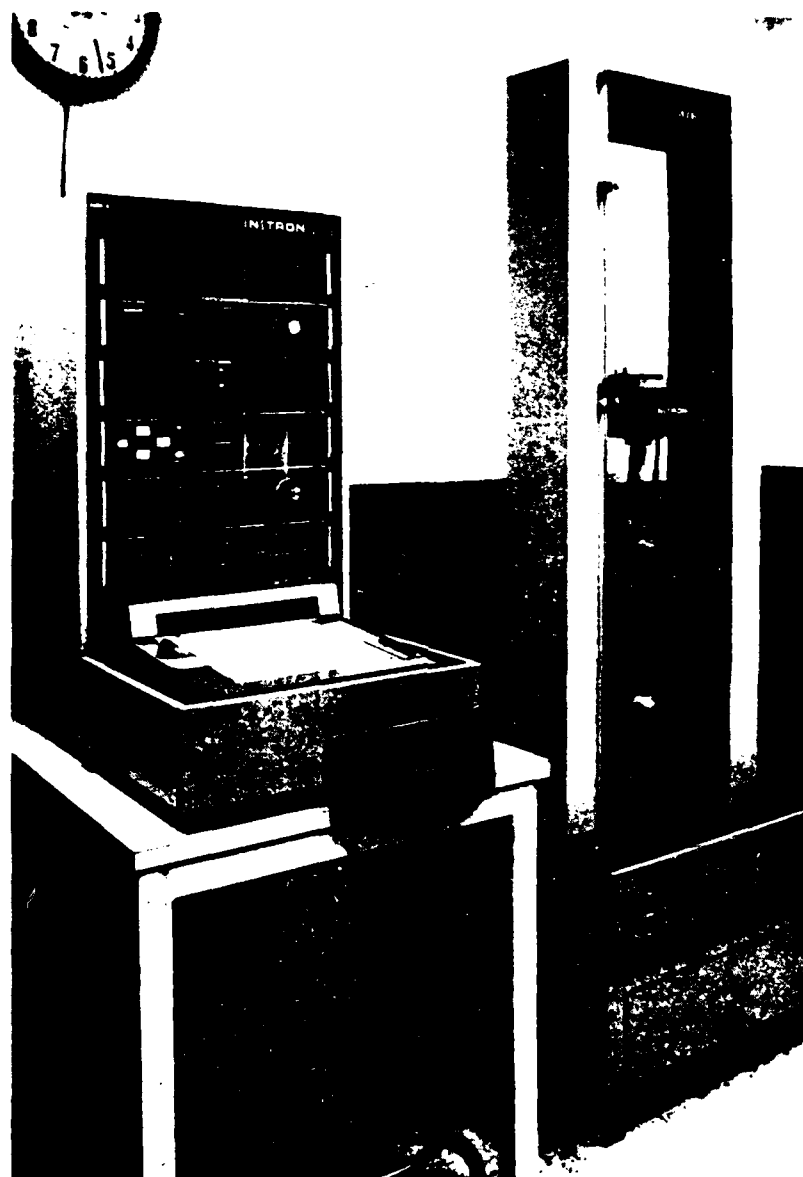
Figure 4. Instron Model 1120 Tensile Tester.

This instrument is best suited to the precise determination of the mean failure strength and the distribution of failure strengths of ~0.5 m fiber samples. By performing tests at several strain rates, the fatigue properties of the fiber can be evaluated (see Section 4.4 for further discussion). Tests on this instrument also give information about the density of weak points along the fiber but only if long lengths of fiber (on the order of one km or more) are tested. Thorough evaluation of weak points with this machine is impractical because the rate of testing is only 150 m per working day. Such tests are better performed with the 20 m tensile tester or the proof tester (see below). The Instron can also be used for tests of fiber strength in a variety of environments and a variety of temperatures by installing an environmental chamber around the test section. However, this is cumbersome and such environmental and temperature-dependence tests are best performed with the bend tester (see below).

The Instron's strip chart records the load vs crosshead position during each tensile test. We compute the failure strength S_f
